“An attempt at sealing natural water-holes or ‘swallows’ in the River Alyn”

ATTEMPTS TO SEAL RIVER ALYN 'SWALLOWS'

February 10th 1938.

HALKYN DISTRICT UNITED MINES LIMITED

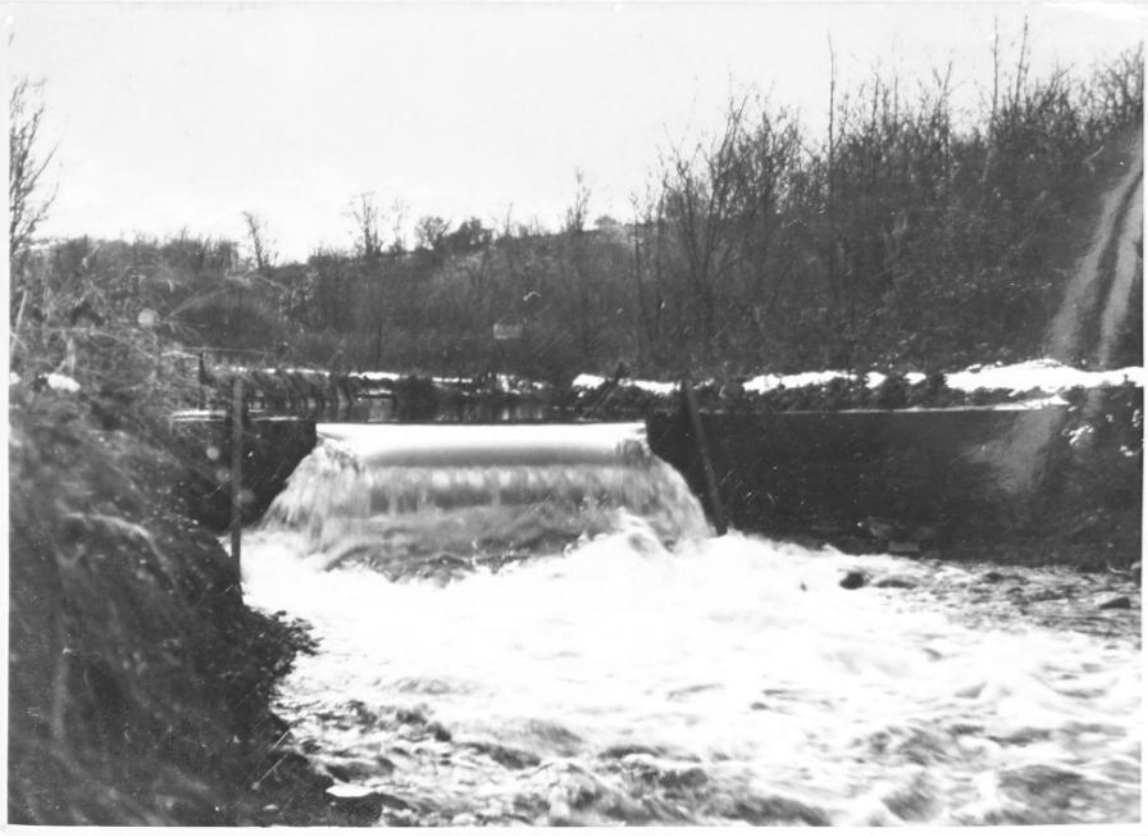
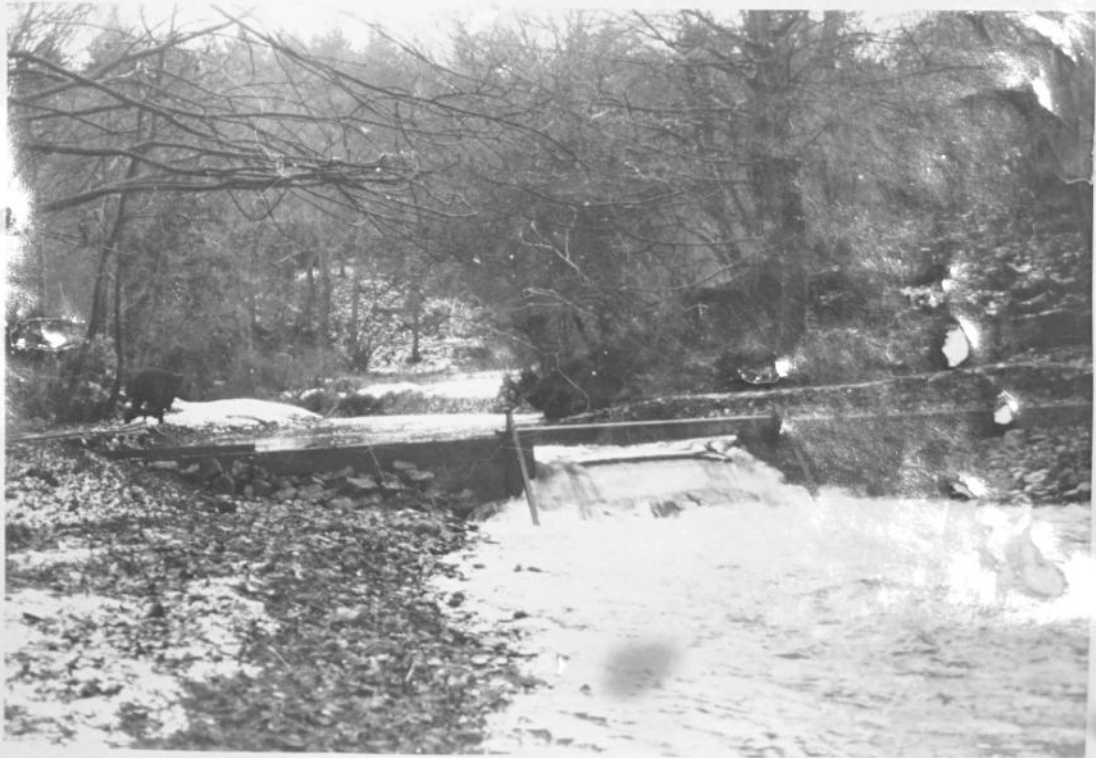
PHOTOGRAPH NO. 1.

During the summer of 1936 a considerable amount of work was done between the Loggerheads and Pont Newydd, which consisted in cutting four new channels (photos 1 & 2) to divert the stream away from known bad sections, building a concrete wall to segregate the flow from leakages at Glan Alyn (photo 3) and exposing fissures and filling them either with concrete or bags of earth. During the ensuing winter floods, it was found, however, that little or no good had been done, and that conditions underground were not improved. This was due to leakages in the diversions and under the concrete fillings, and to the fact that there were many hidden 'swallows' which had not been exposed for filling.

Glan yr afon	(damaged)
	Footbridge	(damaged)
	Big Tree	(damaged)
No. 1	Glan Alyn (photo 3)	
No. 2	Abereilun, in second diversion (photos 1 & 2)	
No. 3	Tan-y-graig (photo 4)	
No. 4	Tan lan	
No. 5	Pensarn	(now dismantled)
No. 6	Maes-y-groes	
No. 7	Bluff	
No. 8	Pont Newydd	
No. 9	Llyn-y-pandy	
No. 10	Nant Alyn	(damaged)

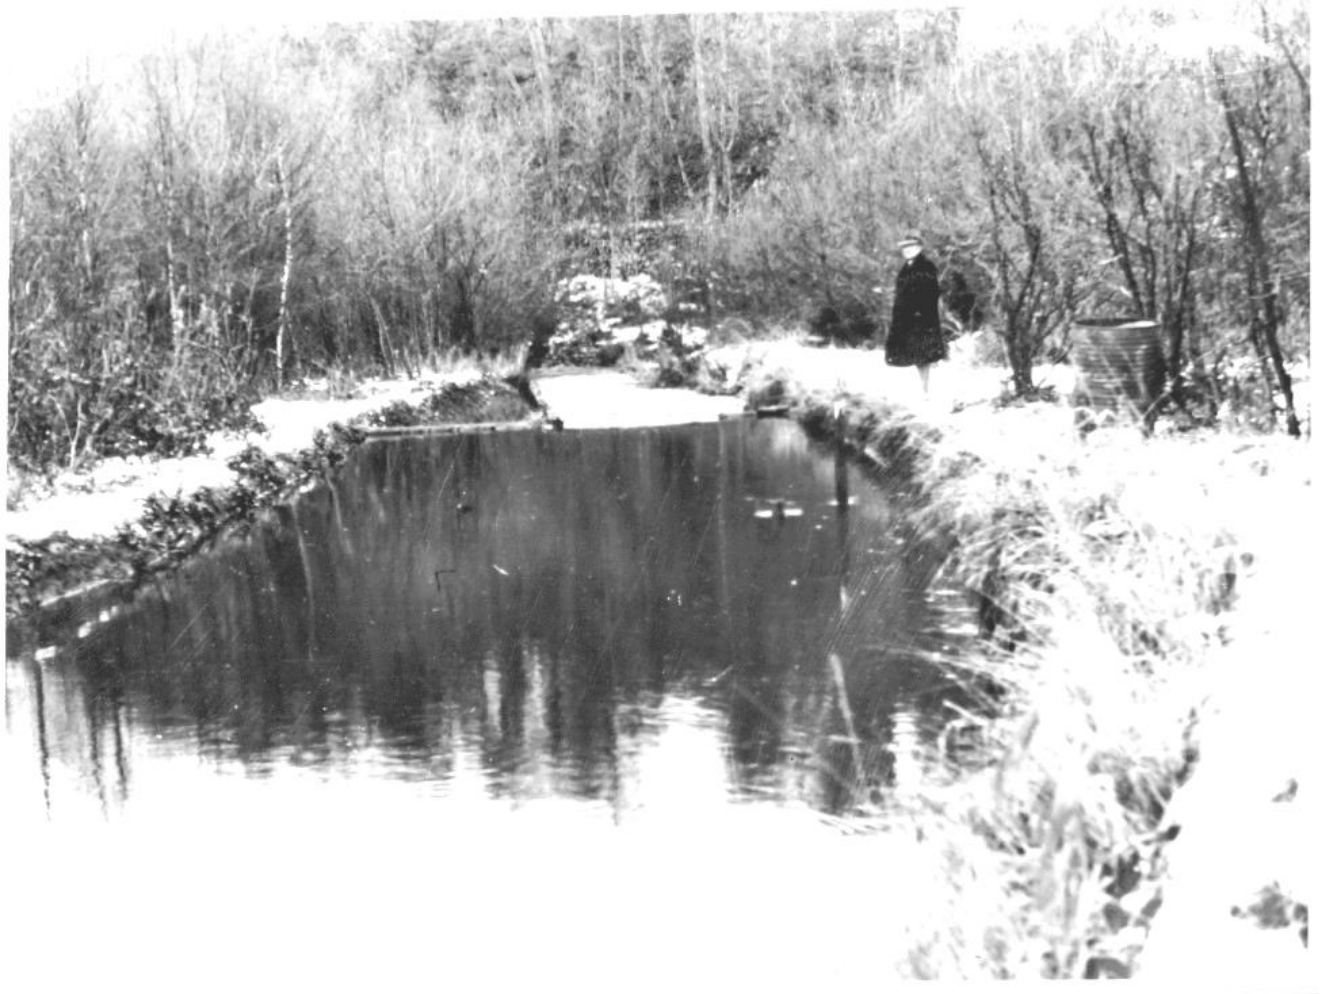
PHOTOGRAPH NO. 2

No. 2 Weir in Aberailun Diversion, looking downstream .

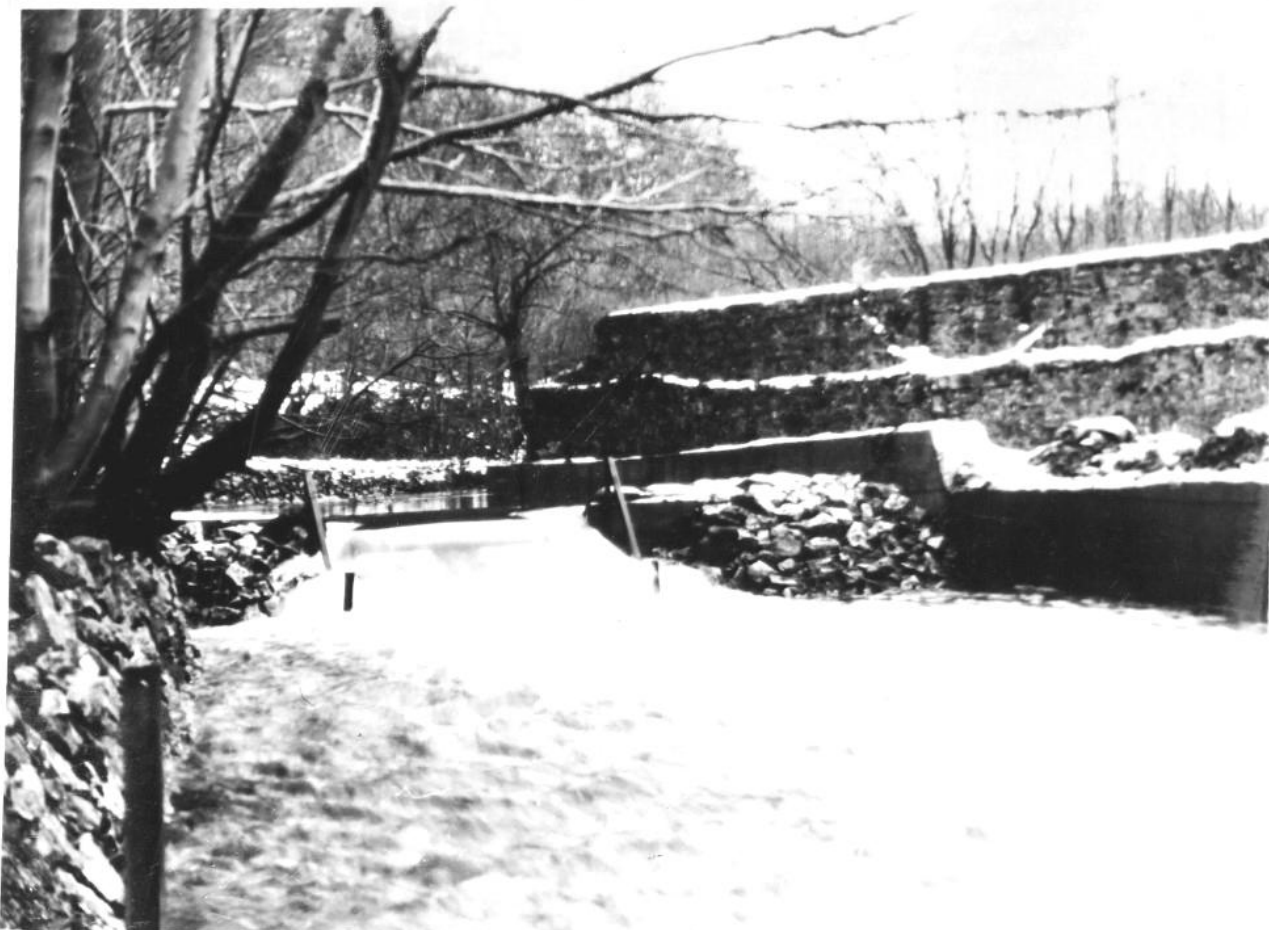
PHOTOGRAPH NO. 3

No. 1 weir at Glan Alun, showing concrete wall on right, and old mill foundations in right background. Dam at downstream end of diversion in distance. Swallows filled in foreground, and area below weir pitched.

This has long been known to be one of the worst areas; as much as 8,000 gpm has been seen to disappear near the old mill on the right bank (photo 3) and there were numerous other leakages in the bed, and in the limestone outcrop on the left bank, past which the stream was diverted in 1936.

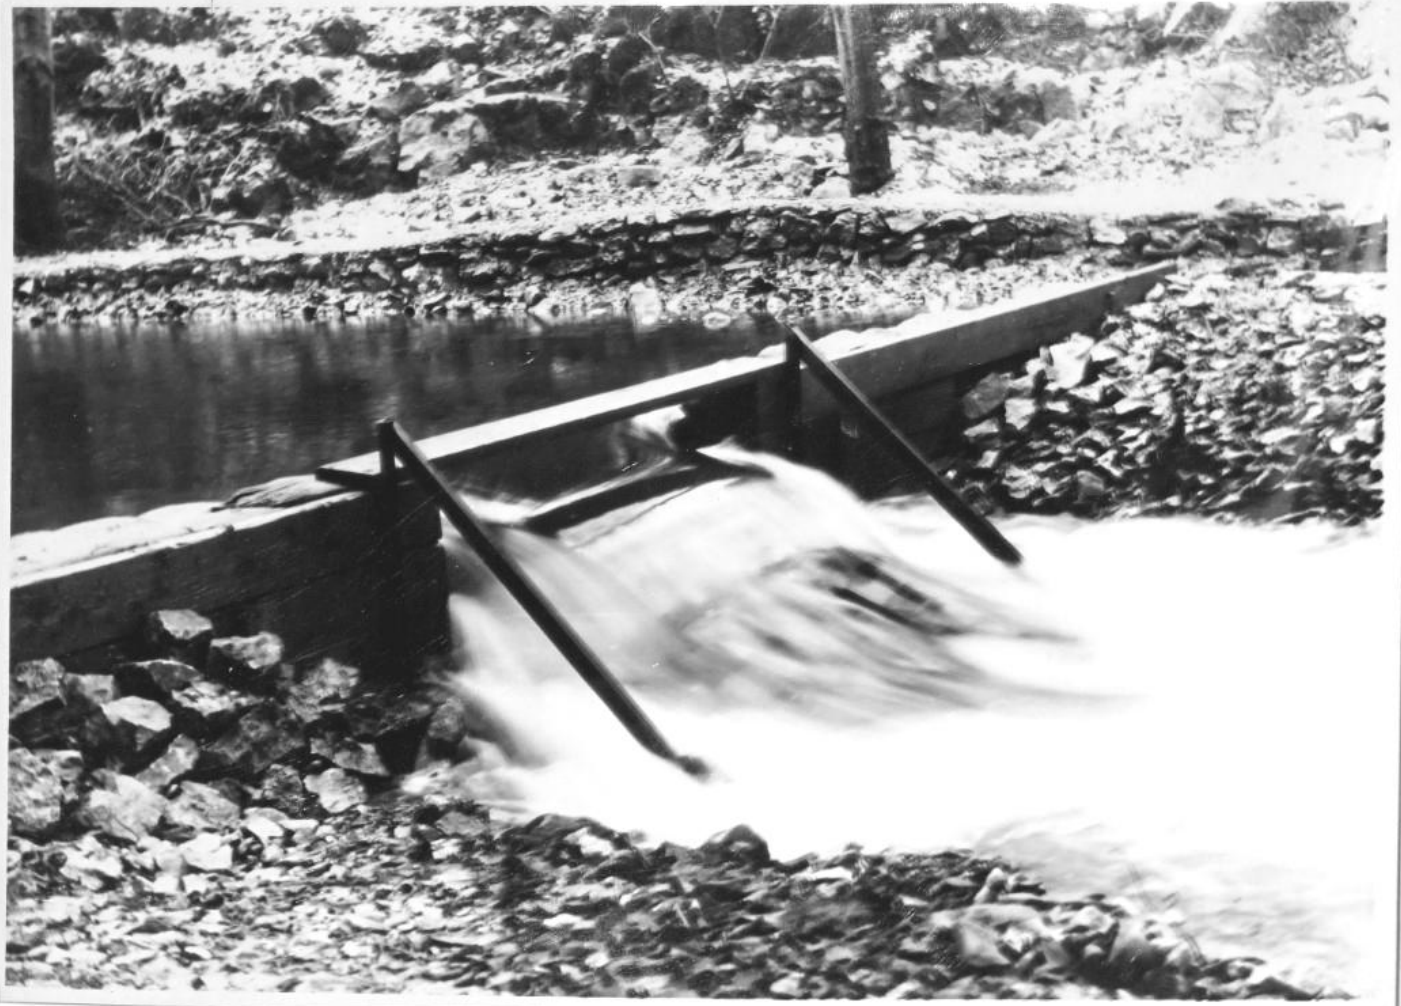
PHOTOGRAPH NO. 4

No. 3 Weir at downstream end of Tan-y-graig Area.
Note wall on far side of bank of river.

These two 'swallows' were amongst the earliest treated, and were first filled with unscreened ashes. These, at the outset, appeared to have reduced the leakages to small dimensions, and there was a small overflow over No.3 weir (photo No.4) for a short time. This soon ceased, when it was noticed that there was a seepage through the fillings, and that a new and larger 'swallow' had opened in the bed above them at 'C' and finally the leakage was traced to 'D'.

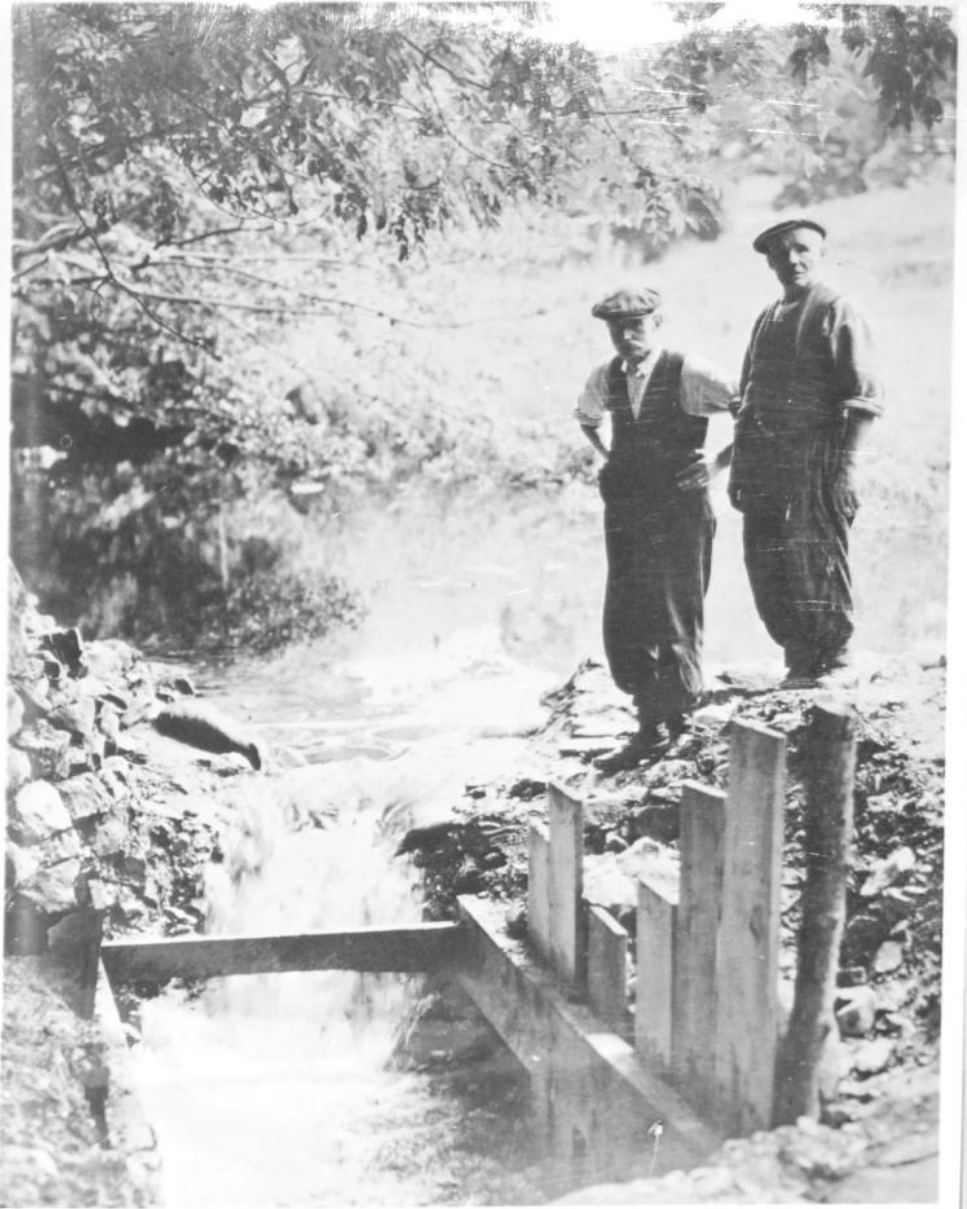
PHOTOGRAPH NO. 5

Leat Wall 'swallow' "B" showing water pouring down
'swallow' before filling.

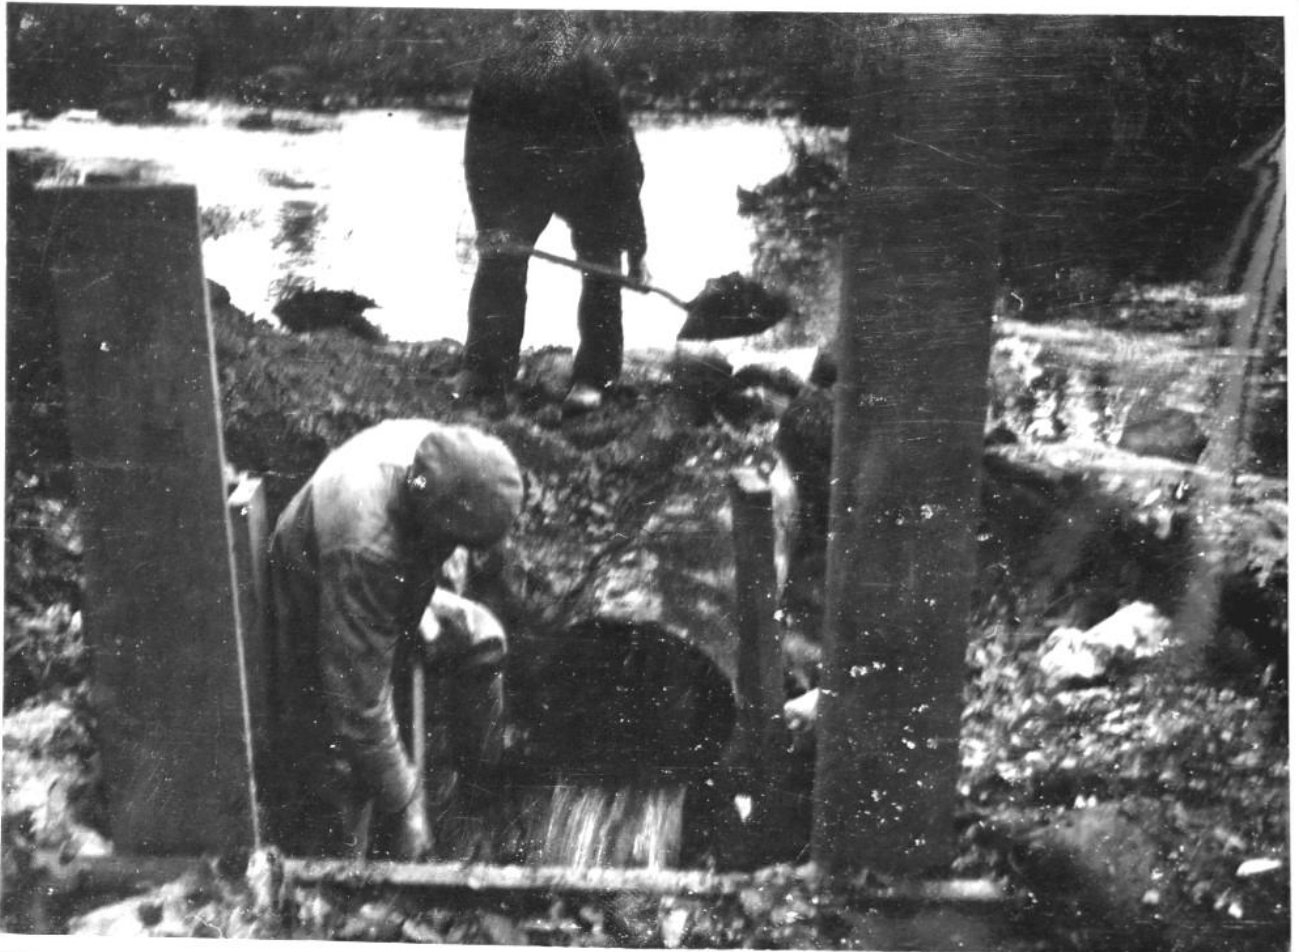
PHOTOGRAPH NO. 6.

Leat Wall 'swallow' "B". Note 20 inch pipe
delivering water and man filling mixture
through hole cut out of pipe.

The 'swallow' was dammed off from the stream and a connection made to it by means of a section of 20 inch pipe, out of which a section 18 inches X 10 inches had been cut, and through which the mixture was fed. This method of feeding through the pipe was used in several cases, and it has the following advantages:

- a) The flow can be diverted directly into the excavation without cascading down the sides and carrying gravel etc. with it.
- b) A grid fixed over the end of the pipe prevents the entrance of leaves etc. into the fissure, and this was particularly important as the work was done in the autumn.
- c) By using a plate over the end of the pipe the flow can be regulated.

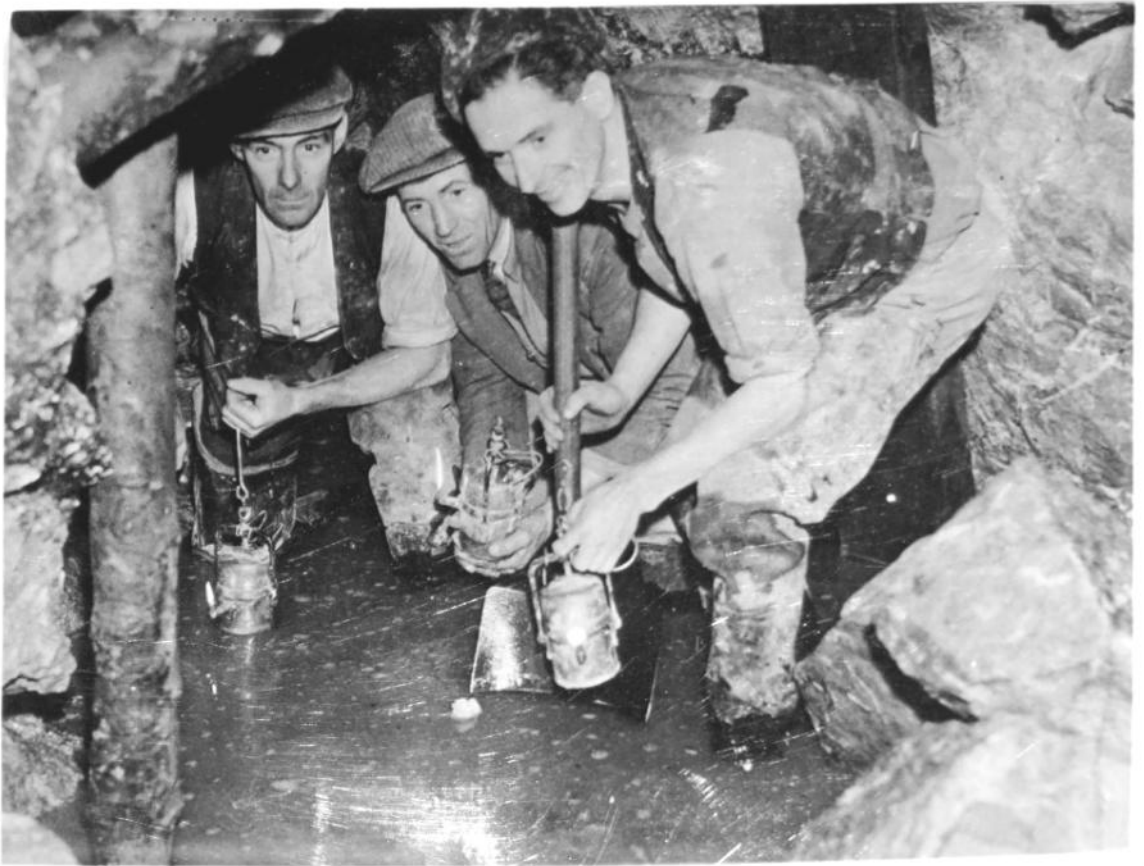
PHOTOGRAPH NO. 8

Men in drift from pit 'G' at Glan Alun.

The third pit 'G' on plan, was sunk downstream and nearer the left bank in order to intercept the feeds which were running horizontally. This at a depth of 22 feet had not got into touch with the water, so a drift (photo 8) was commenced under the left bank, and this in 10 feet broke into a small cavern, through which all feeds appeared to pass. The drift was continued for a total length of 69 feet along the watercourse, which ran more or less horizontally and was at times of small capacity, and as there were no signs of any fissure dipping vertically, the drift was stopped, and arrangements made to fill it with ashes and slimes.

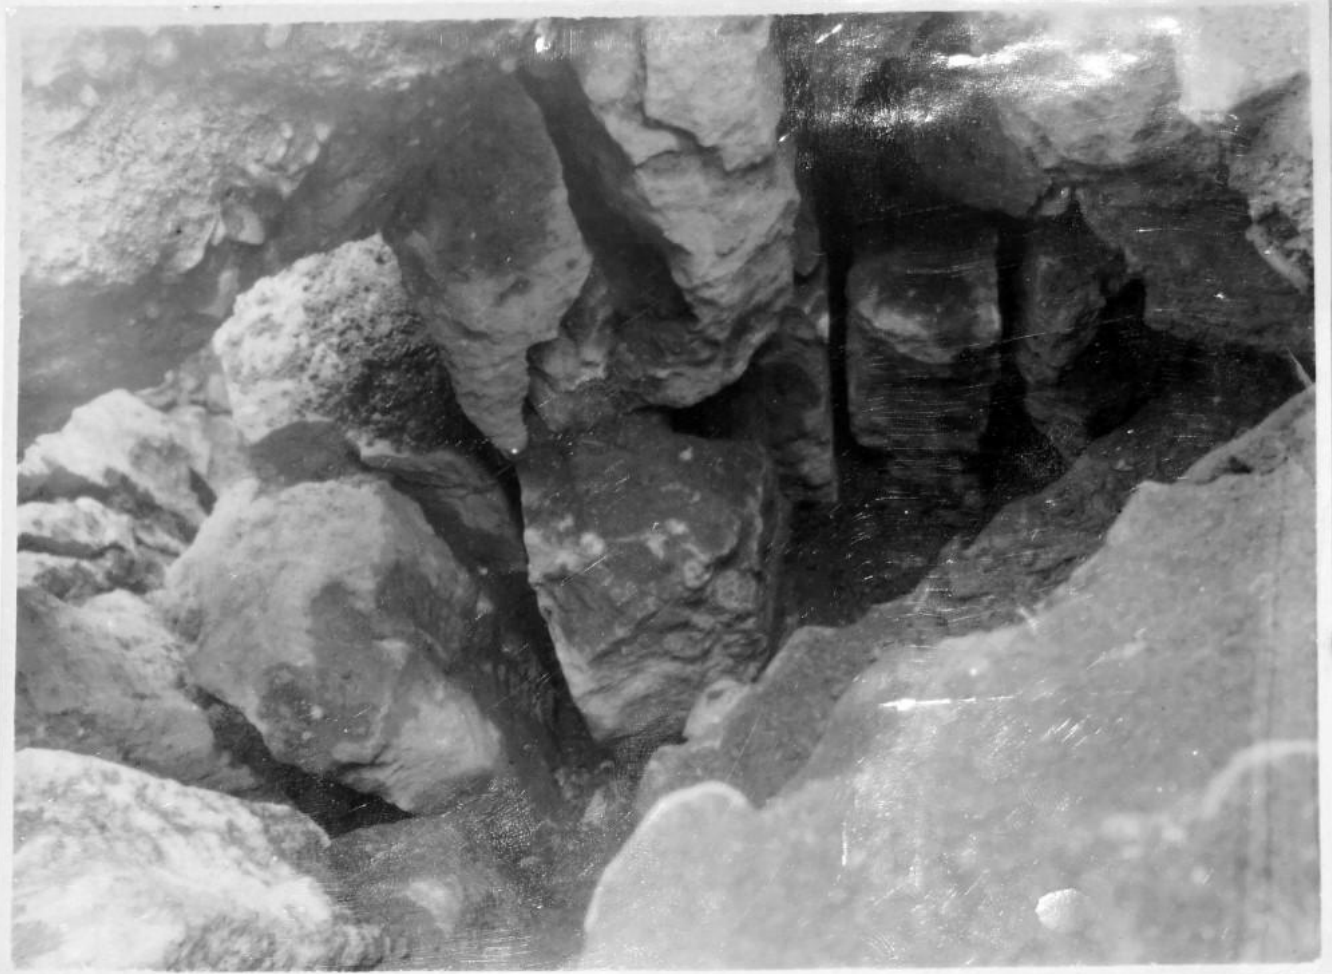
PHOTOGRAPH NO. 9

View downwards to show complicated system of fissures in 'swallow' "B" at Tan-y-graig.

Two important leakages were cleaned down to bedrock at 'A' and 'B' below the point at which the Aberailun Brook joins the main stream, one in the river bed and one on the right bank, the latter being capable of taking several thousand gallons per minute. The bed 'swallow' at 'A' appeared to be honeycombed under concrete which had been laid in 1936, and the fissure in 'B' radiated in all directions over about 270°. The complicated system of fissures in these 'swallows' is shown in photograph No.9.

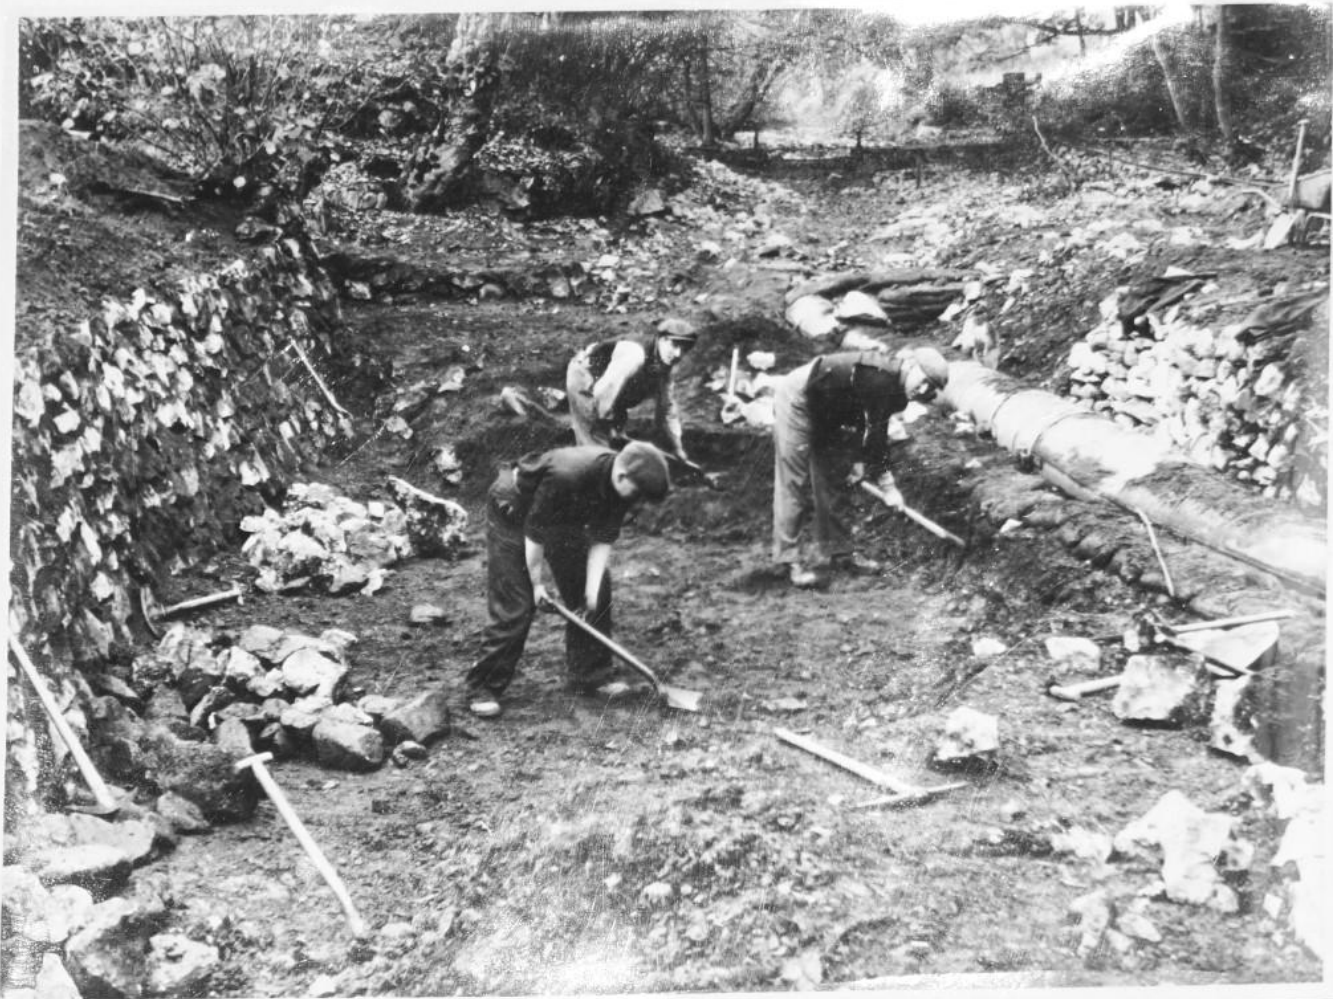
PHOTOGRAPH NO. 10

Cleaning up Tan-y-graig Area after sealing 'swallows'.
By-pass pipe shown on right and No. 3 weir in distance.
Note track from ashes dump on right and retaining wall
on left.

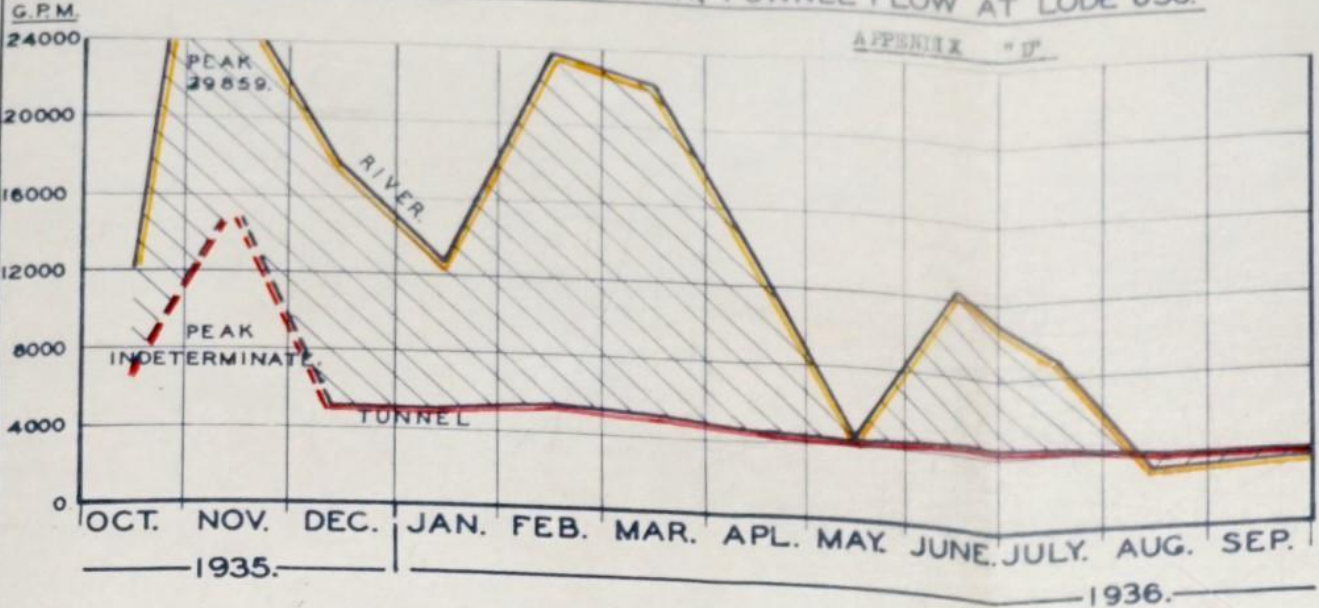
**CHART SHOWING WATER FLOWING IN RIVER ALYN
AND THAT FLOWING IN THE TUNNEL.
RIVER FLOW AT MAESHAFN, TUNNEL FLOW AT LODE 656.**

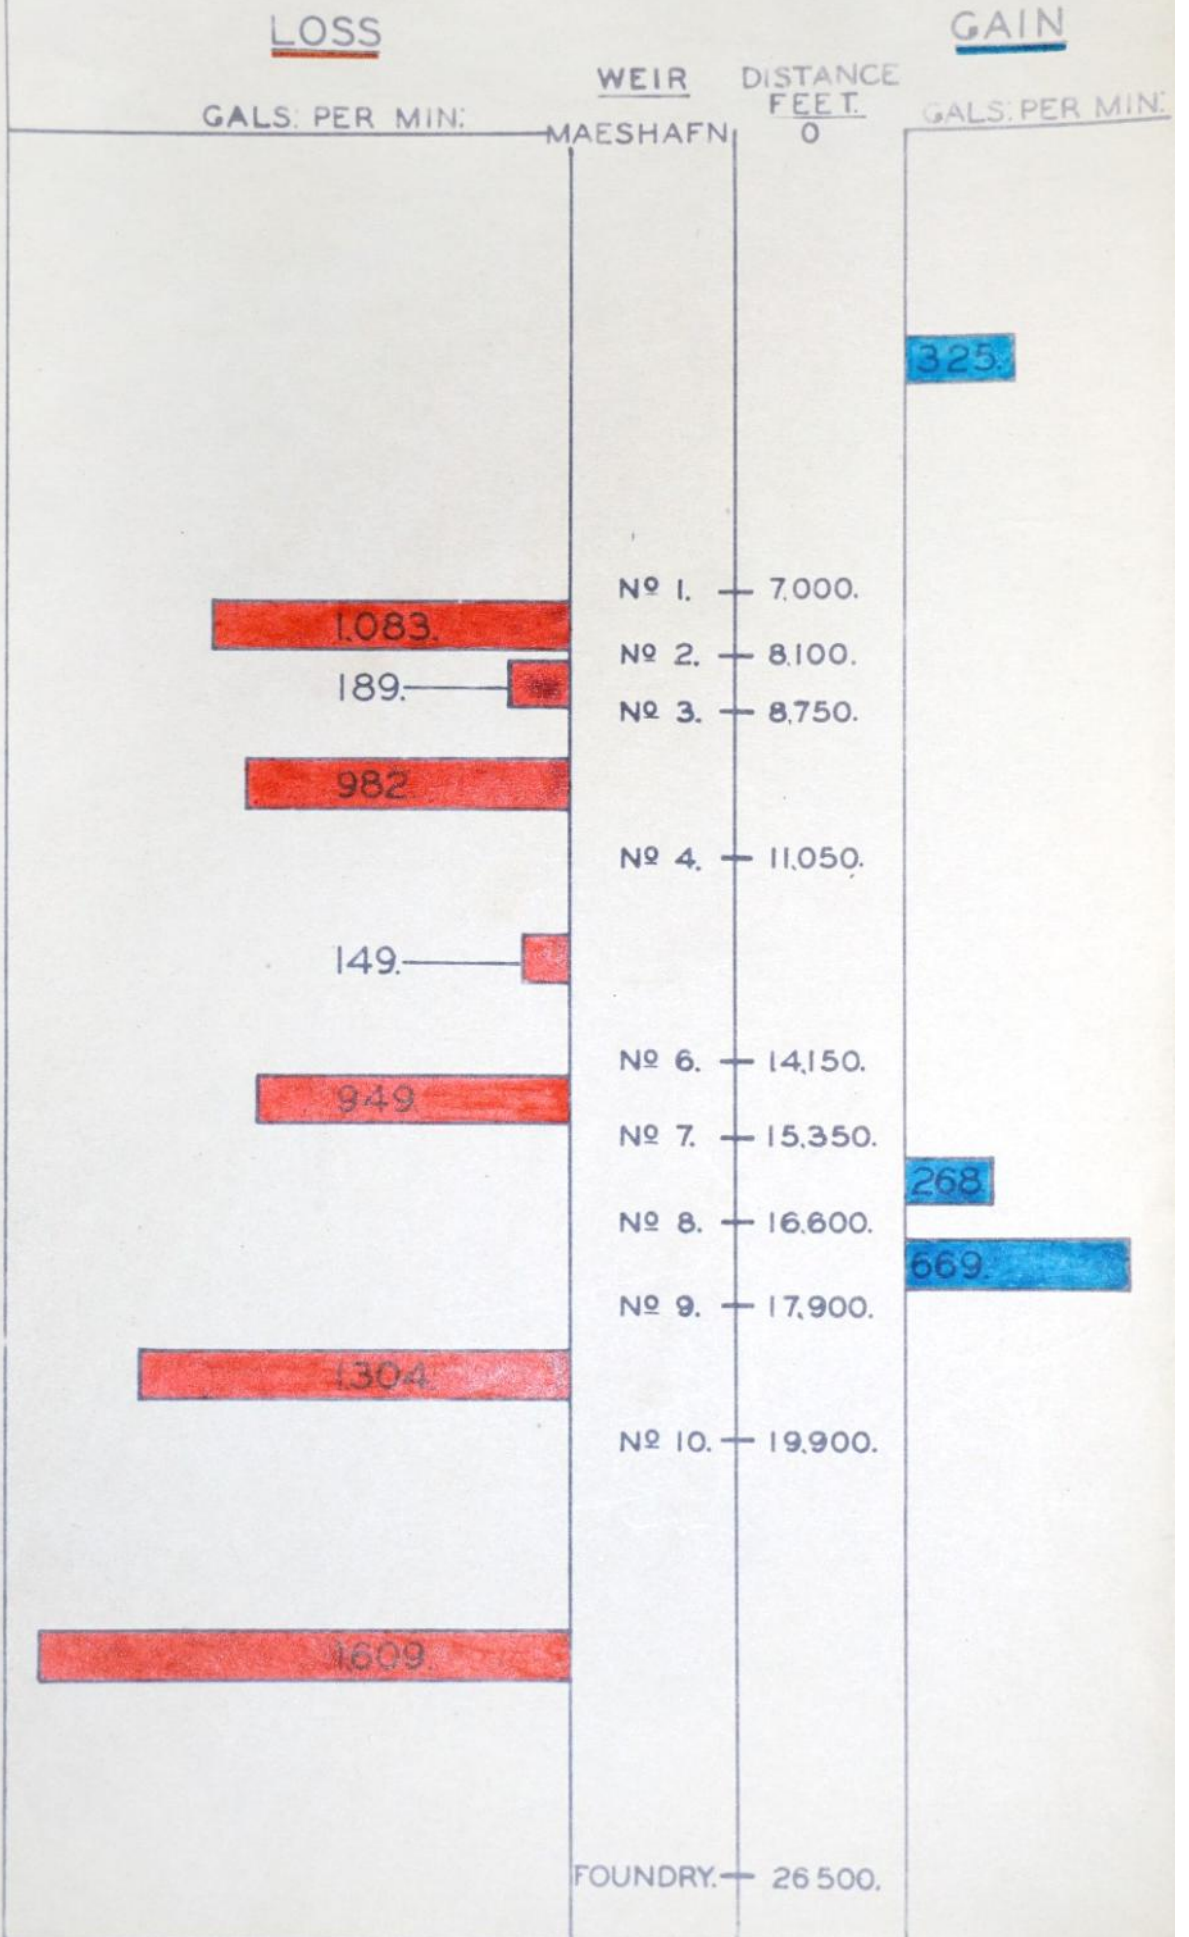
Grand mean of 60 readings from Jan. 1 to March 11th, 1938, dis regarding those when weirs were over flowing.

CHART SHOWING DIFFERENCES IN WEIR GAUGINGS ON THE RIVER.

Appendix 'F' This shows the details of weir gaugings and a graph summarising the leakages between the temporary weirs that were erected along the river during last summer to divide it into smaller sections than hitherto.

Although the gaugings give anomalous results in some cases, the readings of these weirs, together with those of the permanent ones give a much closer idea as to where the leakages in the mine workings are occurring, and from these it appears that the greatest losses are between weirs Nos. 1 to 6, and especially between Nos. 1 and 2 and Nos. 3 and 4. The other most serious loss is between No 9 weir and the Foundry, which is probably fairly equally divided between weirs 9 to 10 and 10 to Foundry, which stretches embrace respectively the Llynypandy and Bryncelyn Lodes. That being so, it would seem that any further work done should be concentrated in those sections of the river bed.
